Name Of Dam: SMITHLEIGH DAM  
Location: AUGUSTA COUNTY, VIRGINIA  
Inventory Number: VA. NO. 01523

# PHASE I INSPECTION REPORT NATIONAL DAM SAFETY PROGRAM

SCHNABEL ENGINEERING ASSOCIATES, P.C./  
J. K. TIMMONS AND ASSOCIATES, INC.

JULY 1980

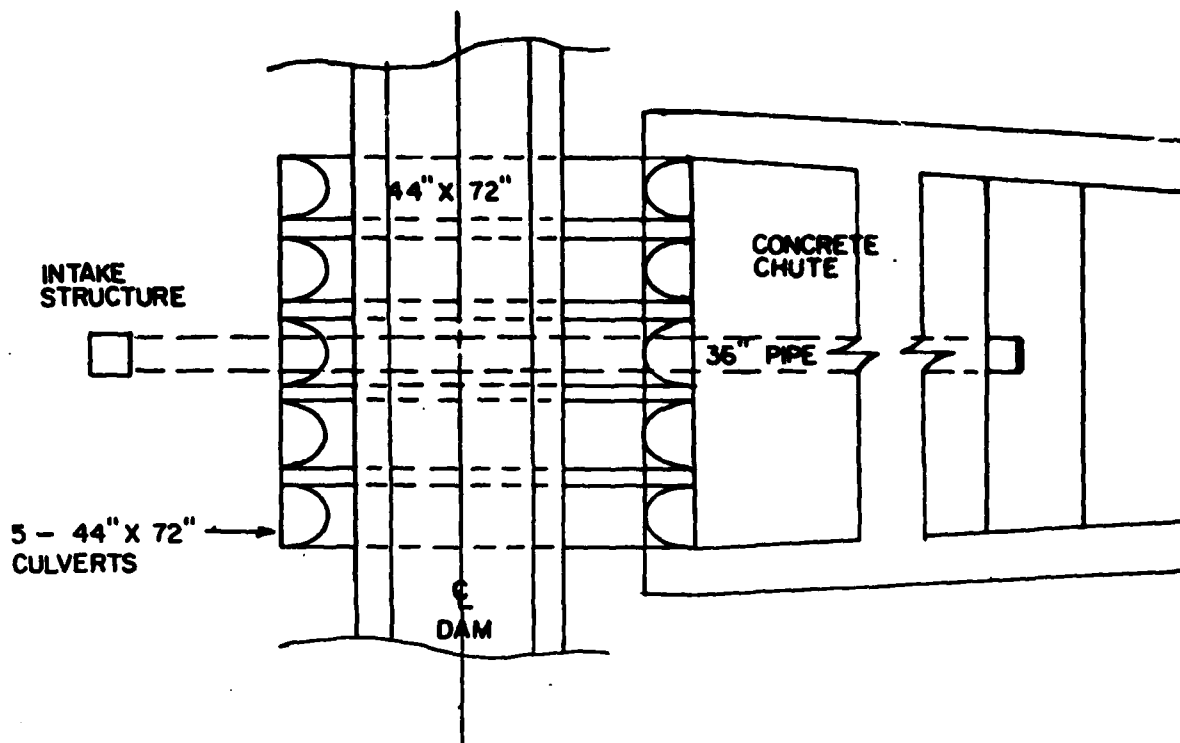
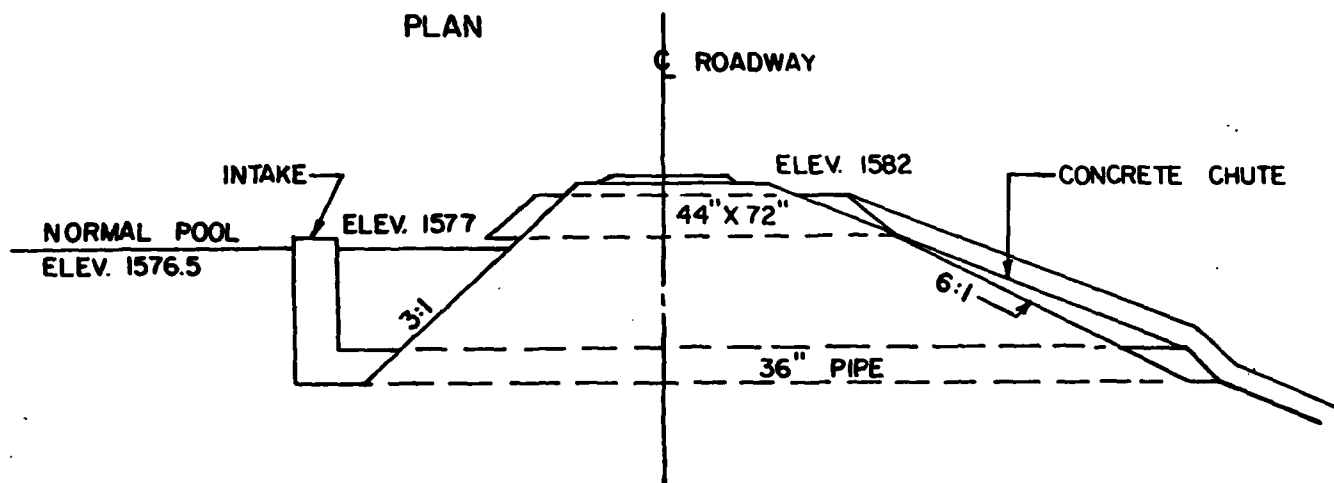
FIELD SKETCH  
EMERGENCY SPILLWAY  
SMITHLEIGH DAM

Ponded water was observed in two areas: (1) along the downstream toe, several 100 ft left of the concrete discharge channel and (2) in an area 60 ft x 25 ft about 75 ft below and to the left of the left edge of the concrete channel. No iron staining was observed and both areas are believed to represent ponded runoff from rainfalls of the preceding day. Just right of area (2) water was flowing through a small opening in the concrete channel at a rate of 5 to 10 gpm. This water is believed to represent water which was flowing beneath and along the side of the spillway. Water also flowing from beneath the concrete channel at rate of 25 to 30 gpm. See accompanying field sketch.

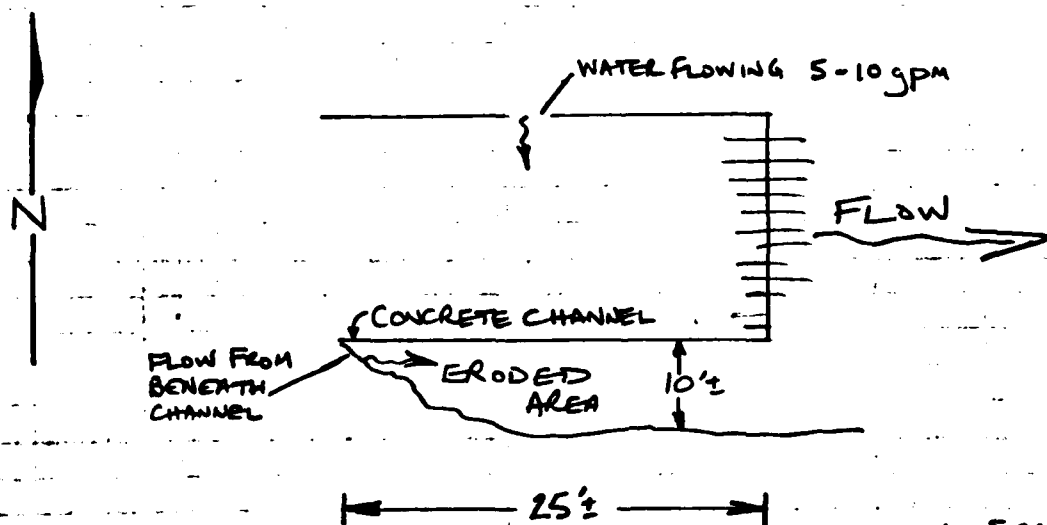
### EROSION, CONCRETE DISCHARGE CHANNEL

The concrete outlet channel is in need of erosion protection. The downstream channel below the outlet channel is also in need of erosion control. The erosion on the outlet channel and downstream channel is severe enough to cause damage to the outlet channel if left unchecked. This could ultimately be detrimental to the dam performance.

Good, no erosion was observed except along the edges of the concrete spillway. The embankment and abutments are well grassed. The existing riprap provides excellent protection for the upstream slope and lower reservoir slopes. The stream channel includes sandy to clayey materials with some gravel (alluvial). The dam and surrounding hillsides consist of silty clays and clayey silts with rock fragments. No bedrock was encountered. Erosion is described on the accompanying field sketch. No faults were observed and none are indicated on existing geologic maps.

7.3.1 Repair eroded areas on the outlet channel and downstream channel, and provide erosion control measures such as riprap to prevent future erosion. Areas which are undermining the outlet channel should also be backfilled and protected.
